POWER2010-27178

CIRCULATING WATER PUMP MODIFICATIONS PERFORMED IN CONJUNCTION WITH COOLING TOWER REPLACEMENT DURING A 35-DAY OUTAGE

Robert M. Morgenstern
ProPump Services, LLC
Bethlehem, PA USA 18020

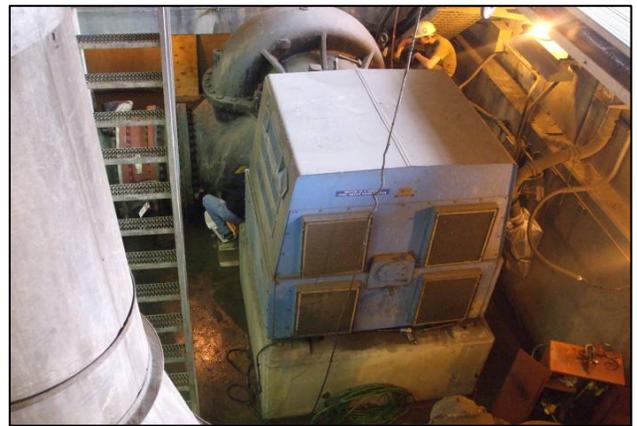
FIGURE 2: PUMP AND MOTOR MOUNTING

Pump, driver and base condition was reported as deteriorating over time (Figure 2). All of the pumps had been refurbished, however, significant casing damage was observed within the hydraulic passages, critical fits and packing bores. In addition, the impellers revealed significant damage due to cavitation and subsequent vane breakage. One of the baseplates had previously been replaced due to corrosion; the other two also exhibited poor condition.

- Provide new wear parts
 - Impeller rings
 - Shaft sleeves
 - Bearings
 - Gaskets / packing / miscellaneous
- Plane and rebore casings
- Coat casing internals with high grade epoxy
- Provide resistance temperature detectors
- Reassemble
- Inspect and repair / replace baseplates

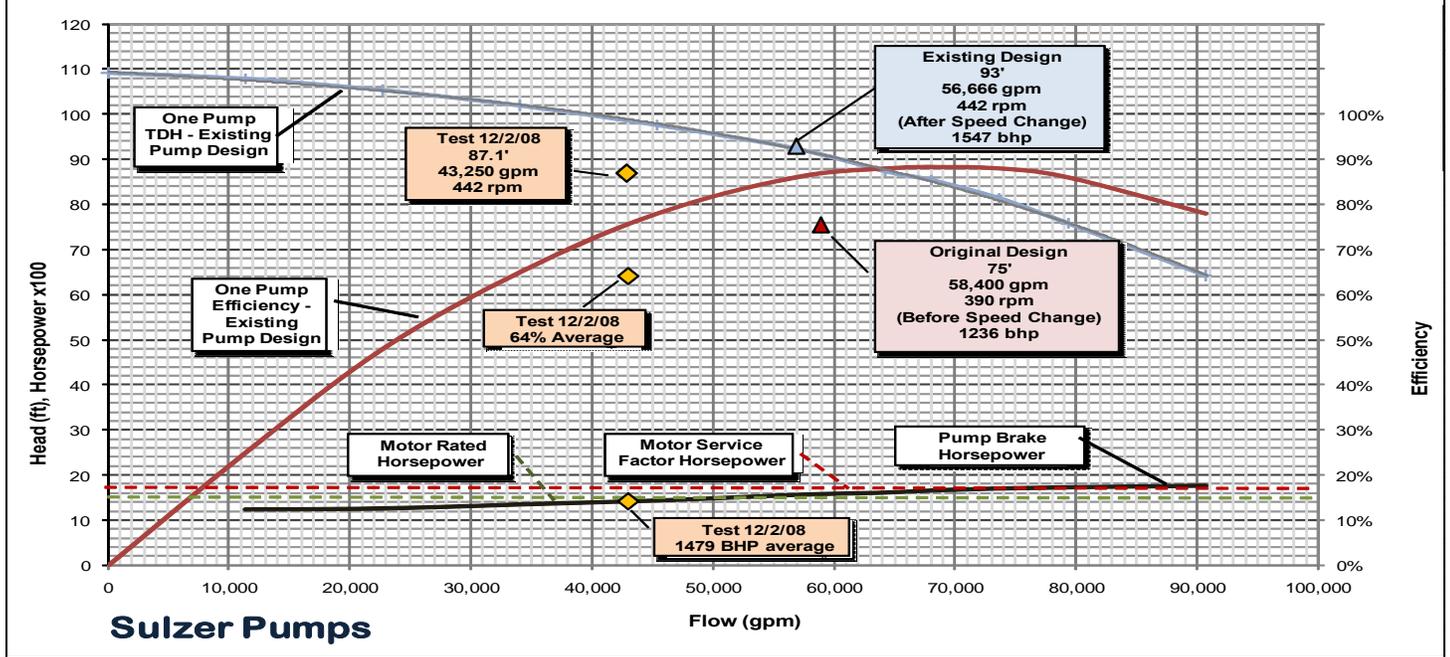
FIGURE 5: MEASURED HYDRAULIC PERFORMANCE

The measured hydraulic data for the circulating pumps is displayed in Figure 5. Since the pump flow could not be individually isolated the flow was plotted as being even between the three pumps. It was believed to be lower for 501, basis visual observation of velocity through the trash racks, slightly lower amps (3%), and missing impeller vane segments found in the system.

The Total Developed Head (TDH) was 10.9 ft (11.1%), low compared to the expected head at the measured flow. This indicates that the pumps were worn with excessive ring clearances and/or impeller breakage.

The efficiency was also low by a similar percentage as the TDH, due to excessive ring leakage. The horsepower remained near expected for a “healthy” pump (i.e. the pump is doing work to pump flow through the ring clearances, but it is a loss since it doesn’t increase the H-Q that the pump is producing at the discharge nozzle).

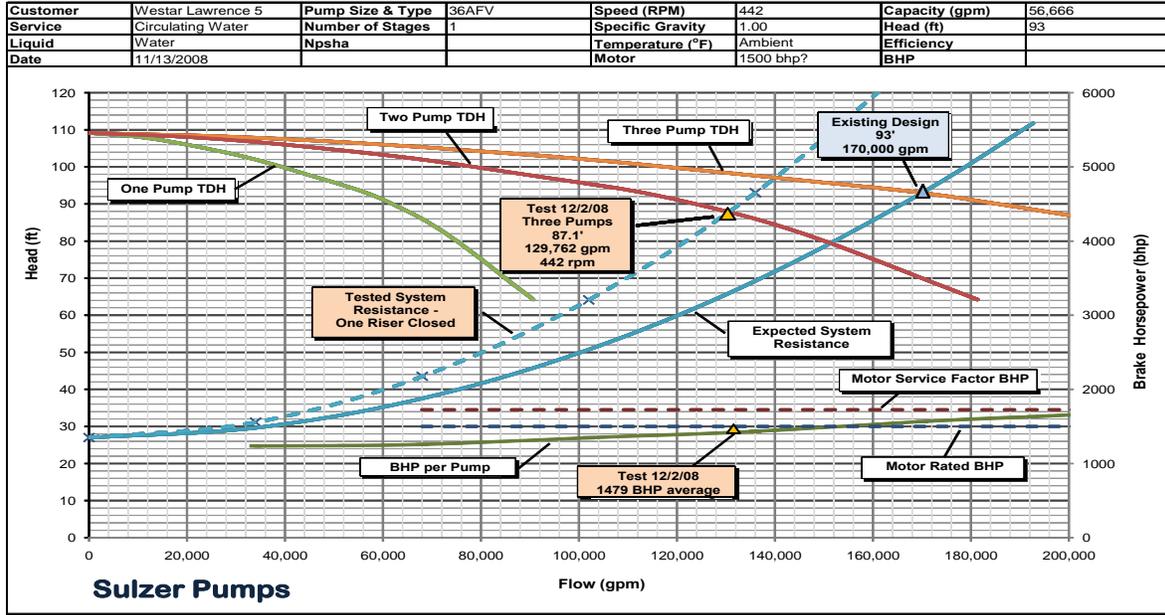
FIGURE 6: PUMP PERFORMANCE VS. SYSTEM CURVE

As shown in Figure 6 below, in addition to the pumps producing low TDH, the system resistance was higher than expected. This was likely due to one closed riser (increases friction loss in remaining risers), condenser pressure drop design value, and basin level below design.

1. The combined pumps were approximately 10.9 ft (11.1%) low in TDH at measured capacity of 129,762 gpm.
2. The pumps were tested with one riser valved out; the expected change with the riser open would be minor.
3. Condenser cleanliness was a factor during testing with:

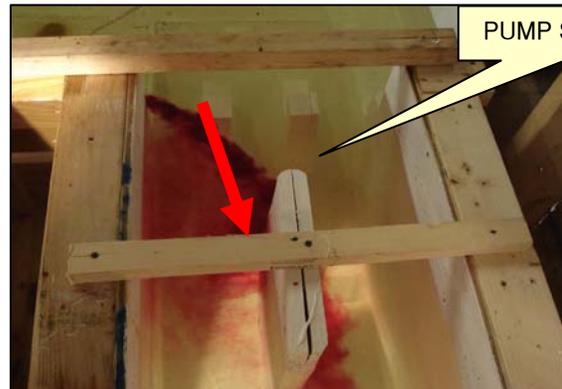
FIGURE 8: FLOW SEPARATION

Testing revealed overall conditions within the intake as turbulent and unstable. There was significant separation at the entrance to the three screen chambers which set up circulation within the common area downstream of the chambers (Figure 8). This increased the instability of flow entering the pump suction pipes. There was significant flow separation at the entrance to each of the pump suction pipes.

The separation was most pronounced along the bottom of the pipe but was observed around the entire circumference. The separation actually caused circulation and upstream flow within the lower portion of the pipe. Frequent Type 3 to Type 5 (air entraining) surface vortices (Figure 9) were observed entering all three pumps during two different pump operating scenarios. Midflow vortices and intermittent floor vortices were also observed entering the pumps, but were less frequent and less severe than the surface vortex activity. Although pre-swirl was low, the recorded pre-swirl values for this intake were higher than expected for dry pit pump suction of this type.

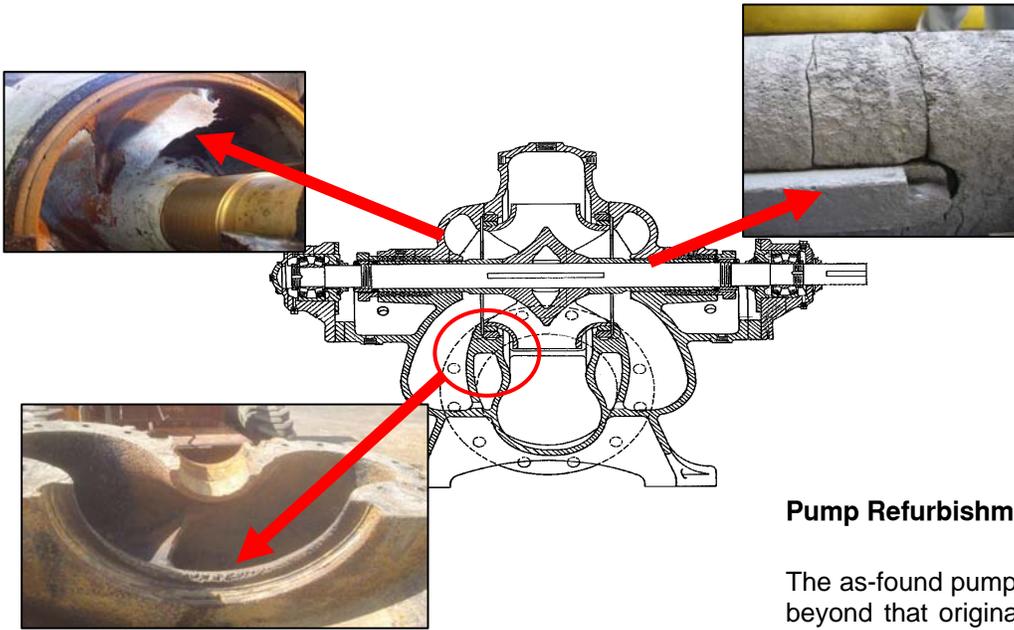
FIGURE 13: INGERSOLL-RAND MODEL 36AFV

Typical Findings – Pump 501 / 502 / 503 (Figure 13)

- Bronze impellers corroded with significant inlet tip damage, pump 501 was missing several large segments of vanes
- Shaft cracked at several locations
- Casing ring “spun” in casing (Pump 501)
- Excess wear
 - Impeller and casing rings
 - Shaft sleeves
 - Bearing housing bores
 - Stuffing box bores
- Casing corrosion throughout the hydraulic passages
- Cavitation damage on the casing at the impeller inlet

The as-found pump condition presented a scope beyond that originally envisioned. Of particular concern was the condition of the casing at the casing ring bores (spun ring on one of the casings), extensive cavitation damage at the suction passage, and packing bores. Due to the unexpected damage, not all of the customer supplied spare parts could be used requiring redesign and expedited manufacture of casing rings, lantern rings, and gland rework.

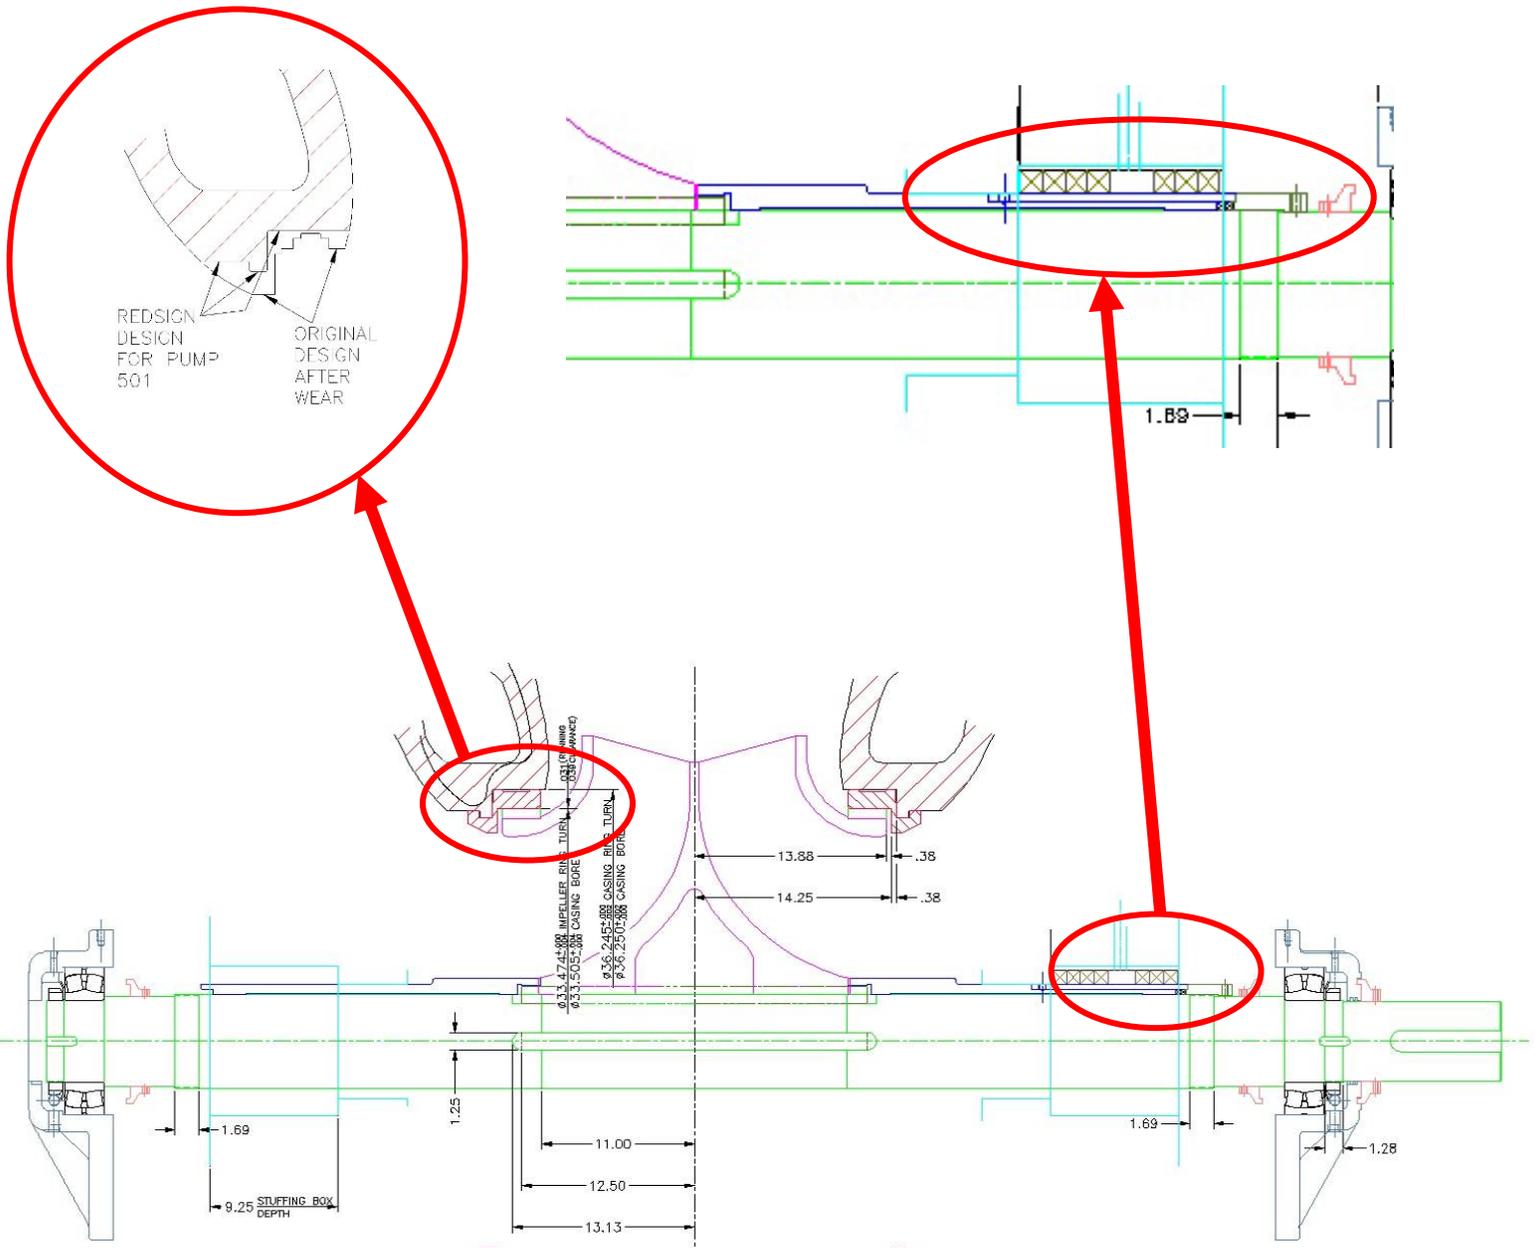
FIGURE 15: REPAIRED AREAS

The condition of the casing bore at the casing rings varied for each of the casings. The most significant damage was observed on pump 501 due to spun rings and cavitation damage. Customer supplied spare rings were not useable thus requiring oversizing the casing bores and manufacturing new 316SS rings with a revised design. The revised design incorporated both the ring and restoration of the cavitation damaged area of the suction passage.

Bronze shaft sleeves exhibited extensive wear at the packing. Refurbishment was accomplished by shrinking and pinning stainless steel sleeves at the damaged area.

Inboard and outboard bearing housings were repaired by sleeving the bearing bore and machining for the Resistance Temperature Detector provisions.

New shafts were provided to replace existing shafts with significant cracking. Shafts were manufactured in 2 weeks to support the pump schedule.

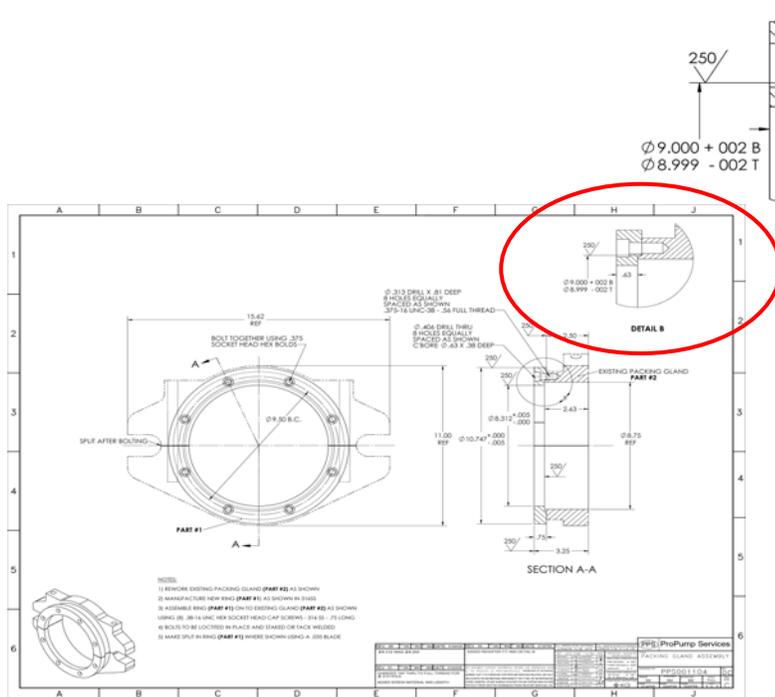
FIGURE 16: HALF GLAND MODIFICATIONS

Damage to the casing stuffing bore also required rework of the half glands (Figure 16) to compensate for the enlarged stuffing box bores.

Damage to the casing stuffing bore required replacement of the noted components; a design was quickly established, manufacturing drawings completed, and orders placed to meet the required lead time.
