**Benefits of Conducting Periodic  
Critical Pump Hydraulic and Mechanical Performance Audits  
By  
John Marchi and Robert Morgenstern  
ProPump Services, LLC**

### Abstract

## Case Study

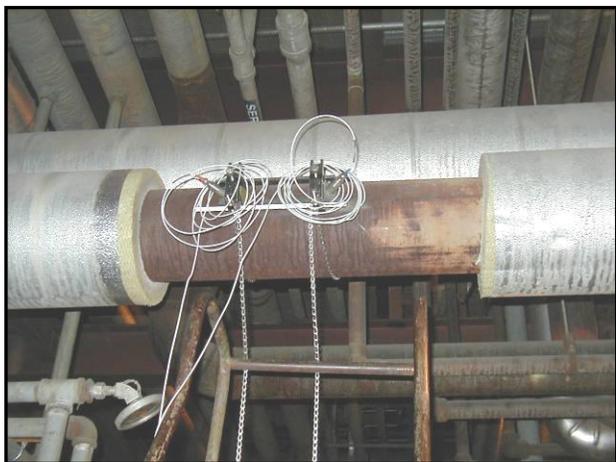
**Figure 4 - Ultrasonic Flow Cells on the Discharge Piping**

The ultrasonic transceivers are mounted external to the piping (Figure 4) and, utilizing transit time algorithms, are able to determine of the flow rate. Typical accuracy is 1% to 2% depending on the installation and configuration of the transceivers.

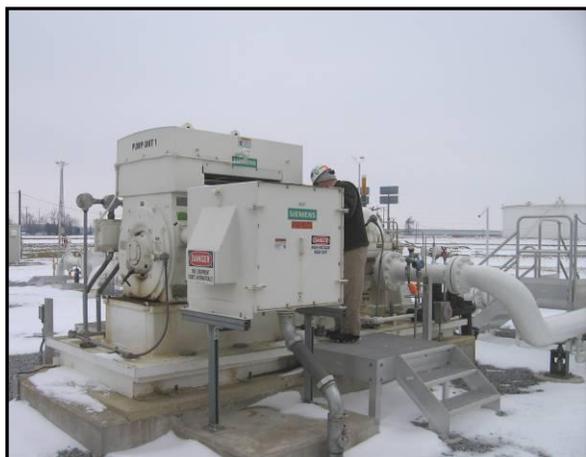
**Figure 5 – Main Line Pumping Unit (MLPU)  
8X10X13-3 Stage Pump**

The subject pump (Figure 5), tagged MLPU 1 is an axial split case 8X10X13 - 3 stage pump in pipeline service. The line transfers crude oil of various viscosities. The pump is driven by a constant speed 2000 Hp induction motor.

The crude is from sources that have known high silica content. It is suspected that the silica is eroding the hydraulic fits within the pump and the seal faces. The current seal flush method is an API Plan 11 which provides for the raw pumpage to circulate from the pump into the seals and back to the pump.

It is recommended that the pump be subjected to a detailed internal inspection of both the rotating and stationary components. It is estimated continued operation of the pump in its current condition will increase annual operating costs by approximately \$111,699.00 (Table 2). Consideration should be given to reviewing the type of materials used for the pump internal components and their compatibility with the pumpage.
