POWER2010-27178

CIRCULATING WATER PUMP MODIFICATIONS PERFORMED IN CONJUNCTION WITH COOLING TOWER REPLACEMENT DURING A 35-DAY OUTAGE

Robert M. Morgenstern
ProPump Services, LLC
Bethlehem, PA USA 18020

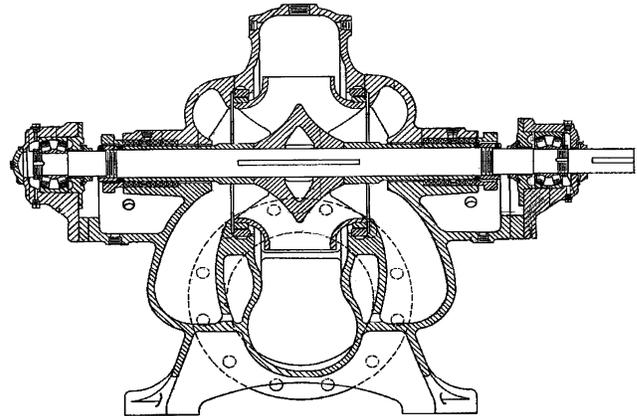
FIGURE 1: INGERSOLL-RAND MODEL 36A FV

The pumps are a single-stage double suction bearing design (Figure 1) featuring a cast iron casing, bronze impeller and carbon steel shafting. Both the inboard and outboard bearings are grease lubricated spherical roller bearings.

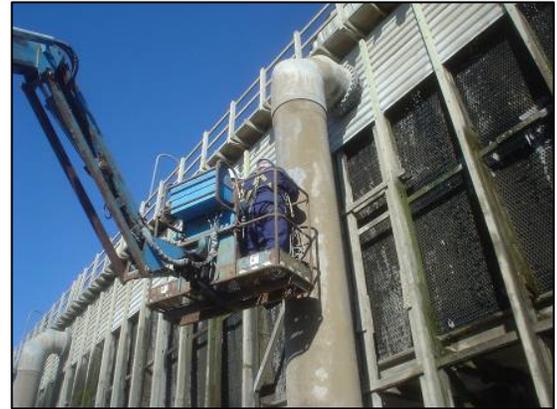
FIGURE 3: FLOW METERING ON RISER #7

Cooling water system capacity was measured on the twelve 30 - inch diameter fiberglass risers using a clamp-on (non-intrusive), ultrasonic flow meter (Figures 3 and 4).

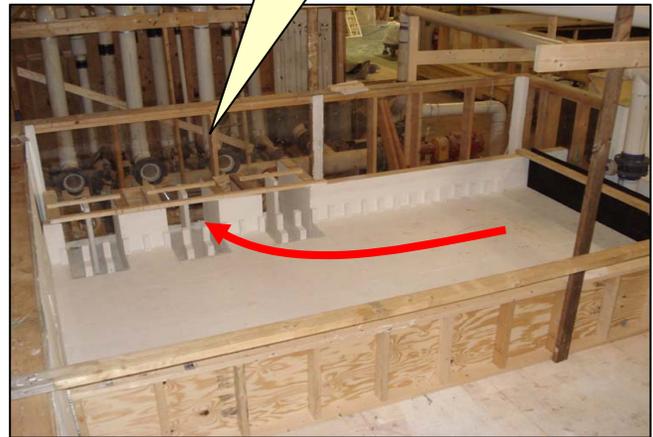
FIGURE 7: PUMP INTAKE MODEL

On-going impeller damage and reduced pump performance were symptoms of the pump intake design issue. Clemson Engineering Hydraulics, Inc. (CEH) was contracted to conduct a physical hydraulic model (Figure 7) study of the pump intake.

Testing revealed overall conditions within the intake as turbulent and unstable. There was significant separation at the entrance to the three screen chambers which set up circulation within the common area downstream of the chambers (Figure 8). This increased the instability of flow entering the pump suction pipes. There was significant flow separation at the entrance to each of the pump suction pipes.

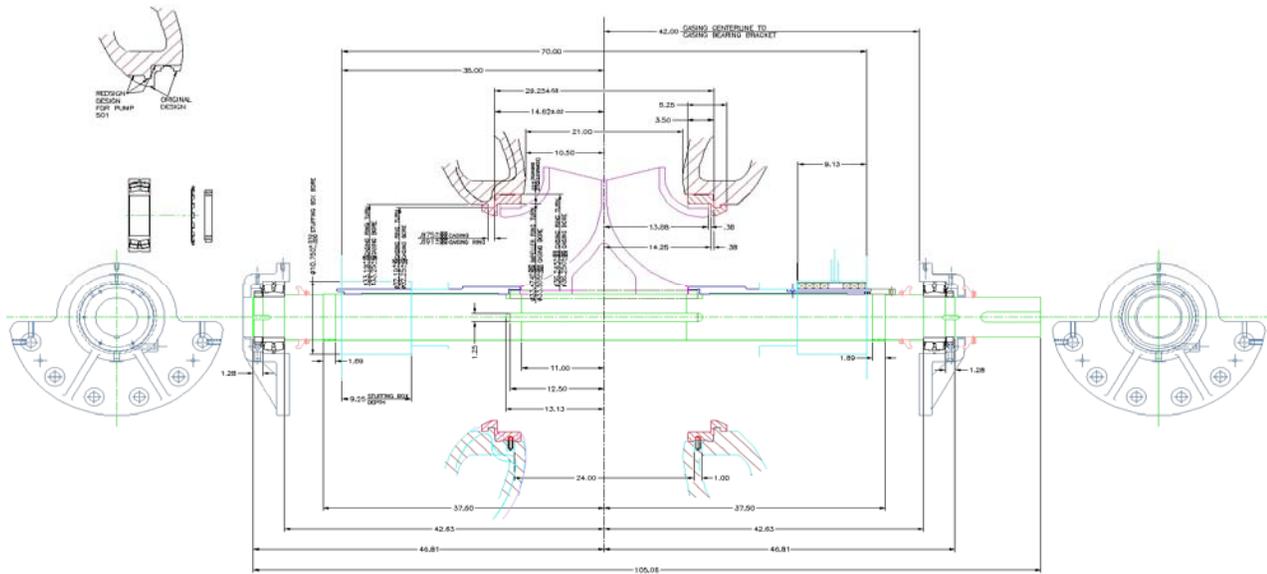
FIGURE 14: ENGINEERING LAYOUT

The as-found pump condition presented a scope beyond that originally envisioned. Of particular concern was the condition of the casing at the casing ring bores (spun ring on one of the casings), extensive cavitation damage at the suction passage, and packing bores. Due to the unexpected damage, not all of the customer supplied spare parts could be used requiring redesign and expedited manufacture of casing rings, lantern rings, and gland rework.

Using the as - found pump geometry and the spare parts an engineering layout of the pump was generated (Figure 14). All damaged areas were thoroughly assessed and appropriate design modifications incorporated as follows (Figure 15):
